SPILLWAY TESTS AT GLEN CANYON DAM

July 1985

Bureau of Reclamation

Hydraulics Branch
Division of Research and Laboratory Services
Engineering and Research Center
Denver, Colorado
July 1985

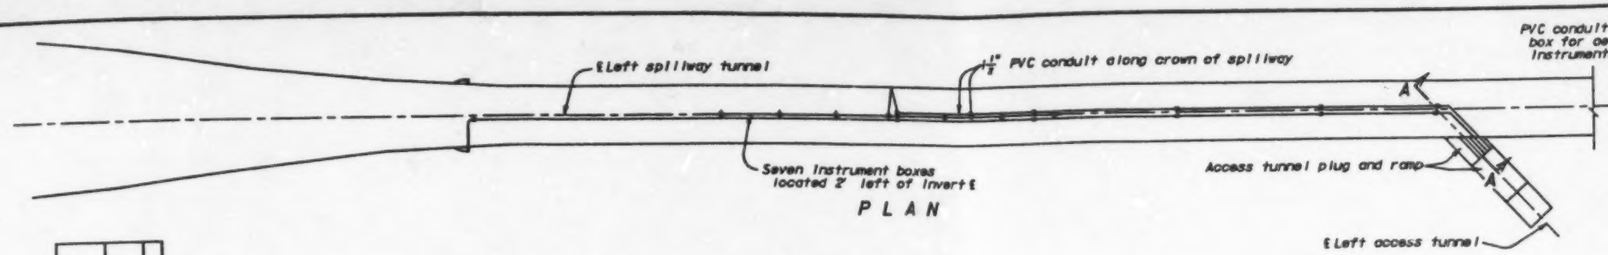
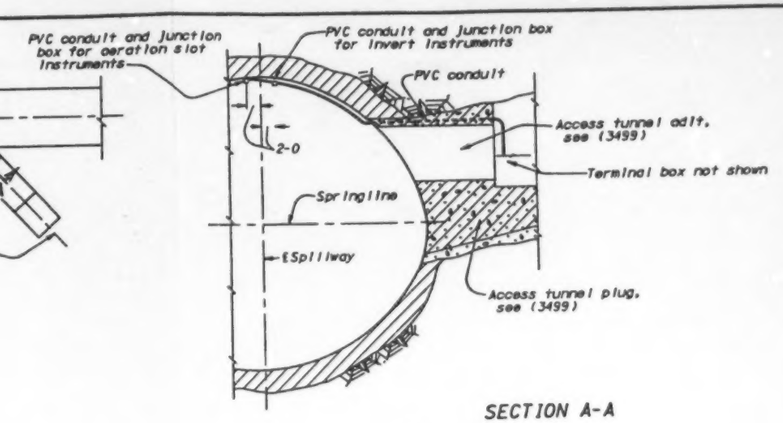
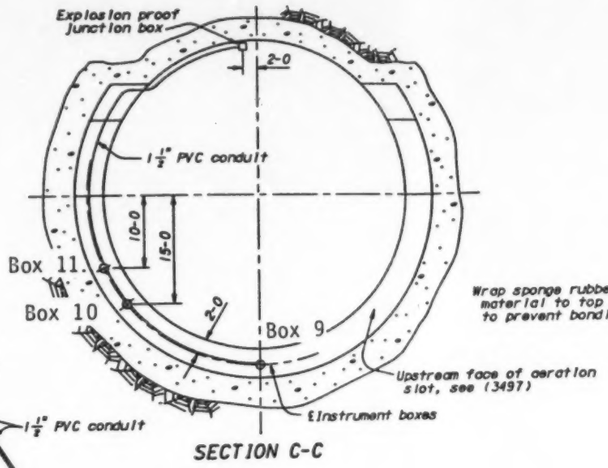
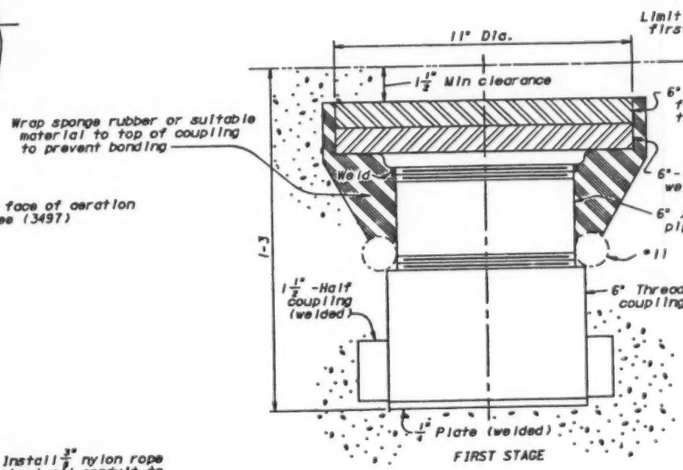
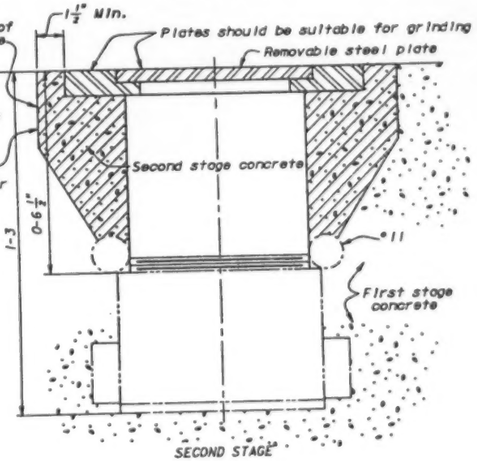
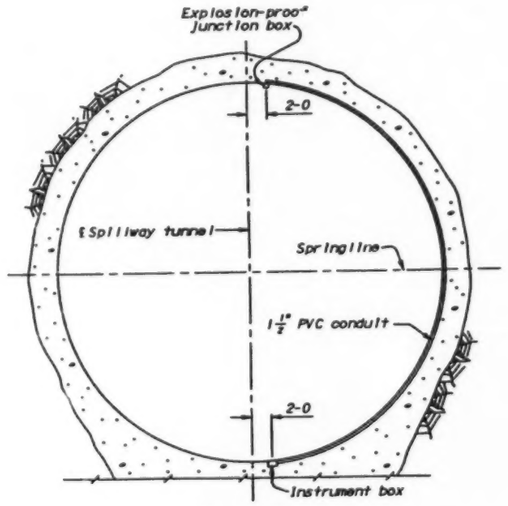
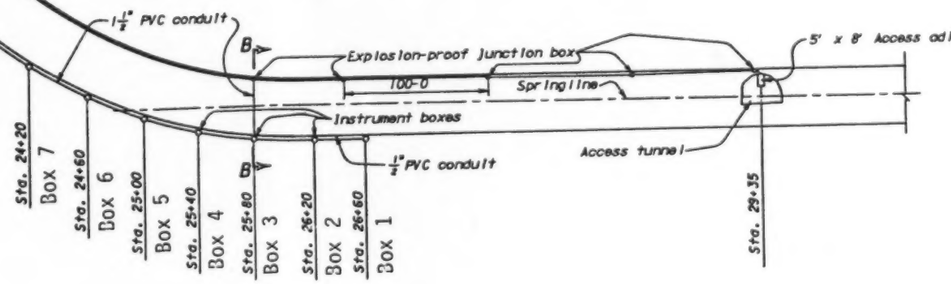
Figure 1. - Glen Canyon Dam - spillway repair.

The instrument boxes were installed flush with the tunnel inside surface as the new concrete was placed in the tunnel invert and in the air slot. Details of the instrument boxes and their locations are shown on figure 1. Problems occurred with leakage into these boxes at the connections with the electrical conduit. In addition, scale and rust accumulated on the removable steel plates. Electrical signal cable was pulled into each instrument box and the appropriate instrument connected. A computer-based data acquisition system was configured to poll and record outputs from all tunnel instrumentation.

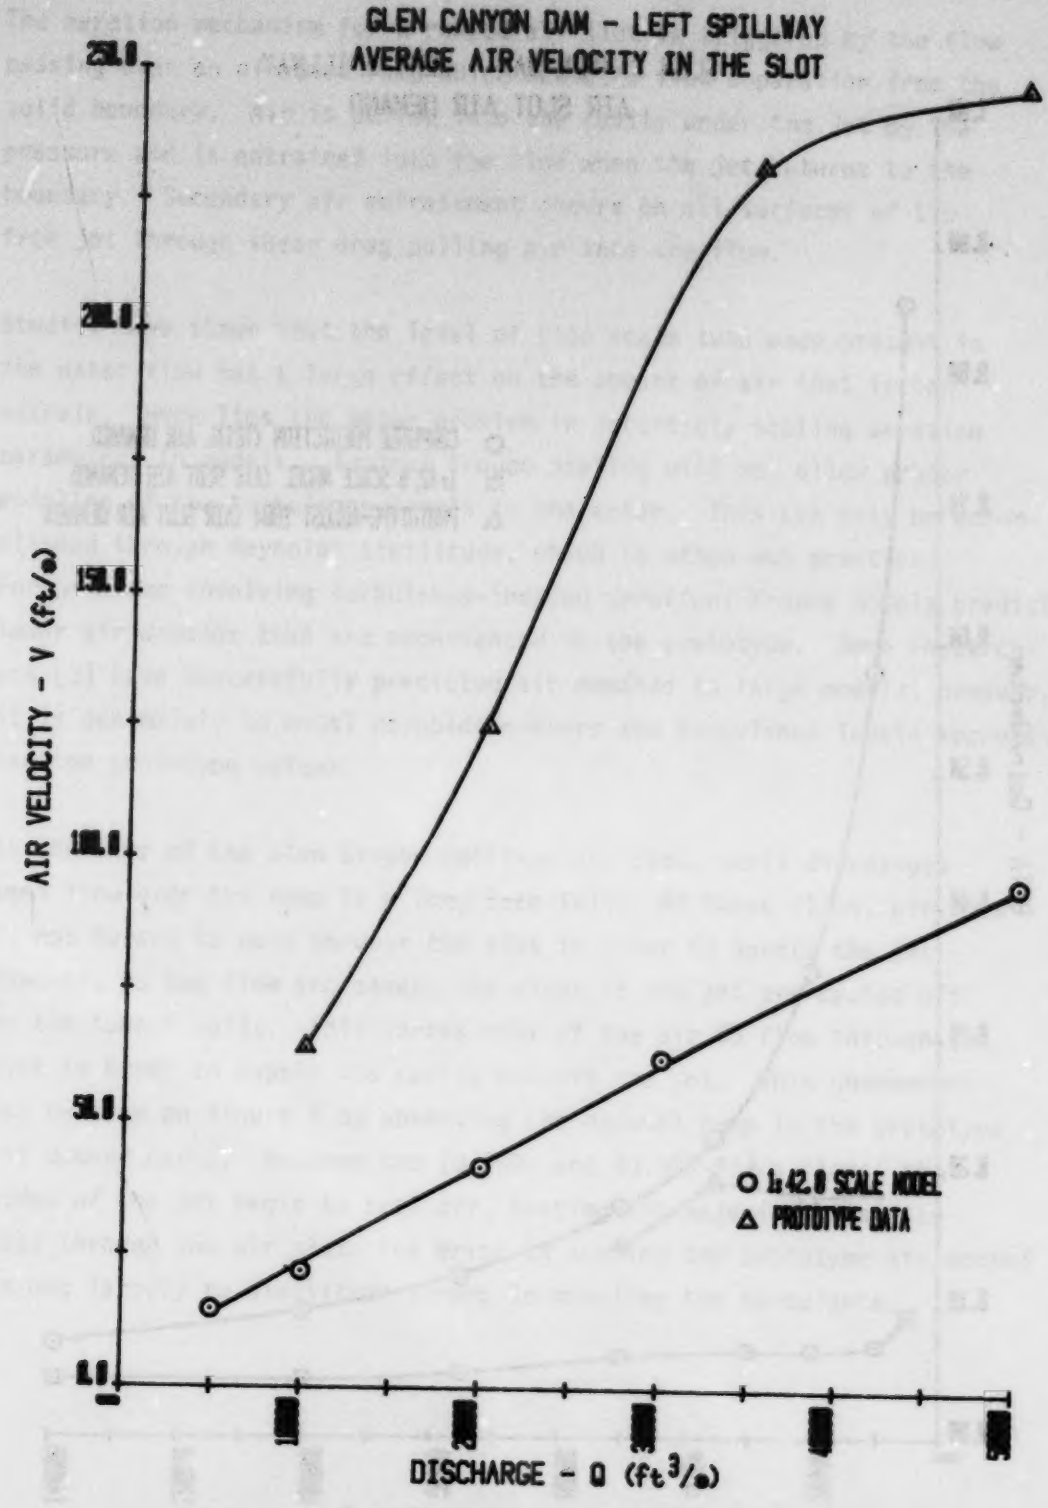
Figure 3. - Air velocity measurements in the air slot.

A comparison of these velocities with scaled model values is shown on figure 3. The single point velocity data can be integrated into a volumetric flowrate by assuming a velocity distribution in the slot. A standard logarithmic distribution was assumed along with symmetric performance of the slot. A comparison of air demand, for model, prototype, and computed data is shown on figure 4. It should be noted that measurements in the model and prototype only reflect air demand passing through the slot. Additional air is entrained through shear drag on the free surfaces of the jet and at flows below 30,000 ft^3/s air may enter beneath the jet downstream from the slot because the sides of the jet are not sealed against the tunnel walls.

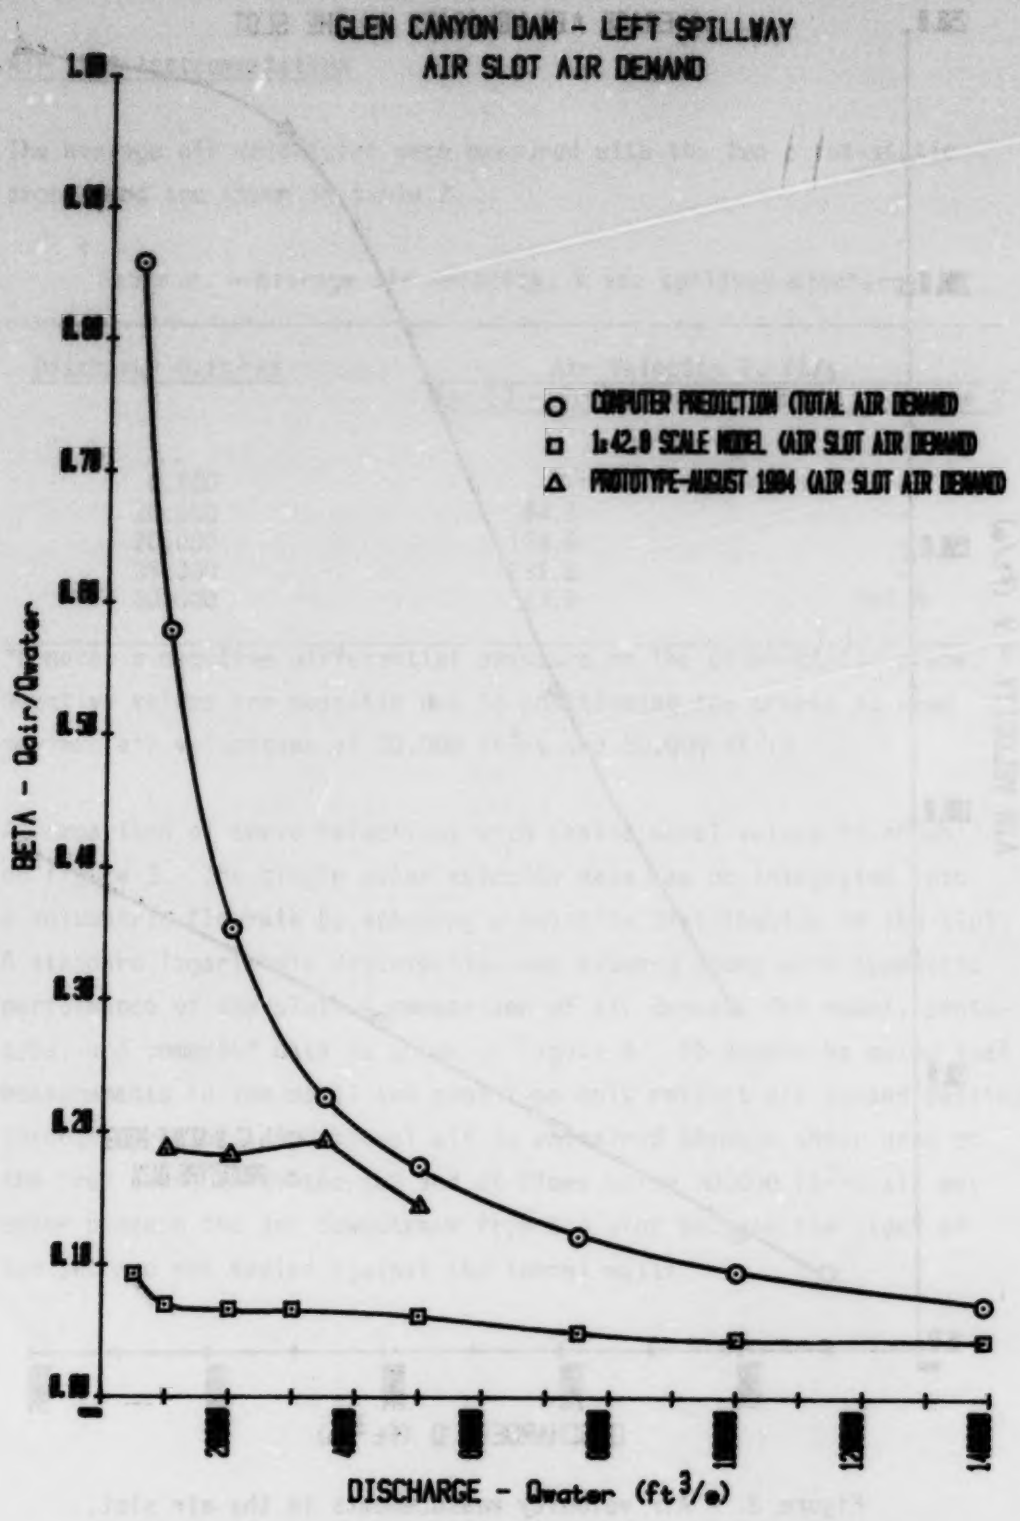
Figure 4. - Air demand comparison - computed-model-prototype.

In the case of the Glen Canyon spillway air slot, small discharges send flow over the ramp in a long free fall. At these flows, air flow is not forced to pass through the slot in order to aerate the jet. However, as the flow increases, the sides of the jet are sealed off by the tunnel walls. This forces most of the air to flow through the slot in order to supply the cavity beneath the jet. This phenomenon can be seen on figure 4 by observing the unusual bump in the prototype air demand curve. Between the 20,000- and 40,000-ft^3/s flows, the sides of the jet begin to seal off, forcing the majority of air to pass through the air slot. The error in scaling the prototype air demand is due largely to similitude errors in modeling the turbulence.

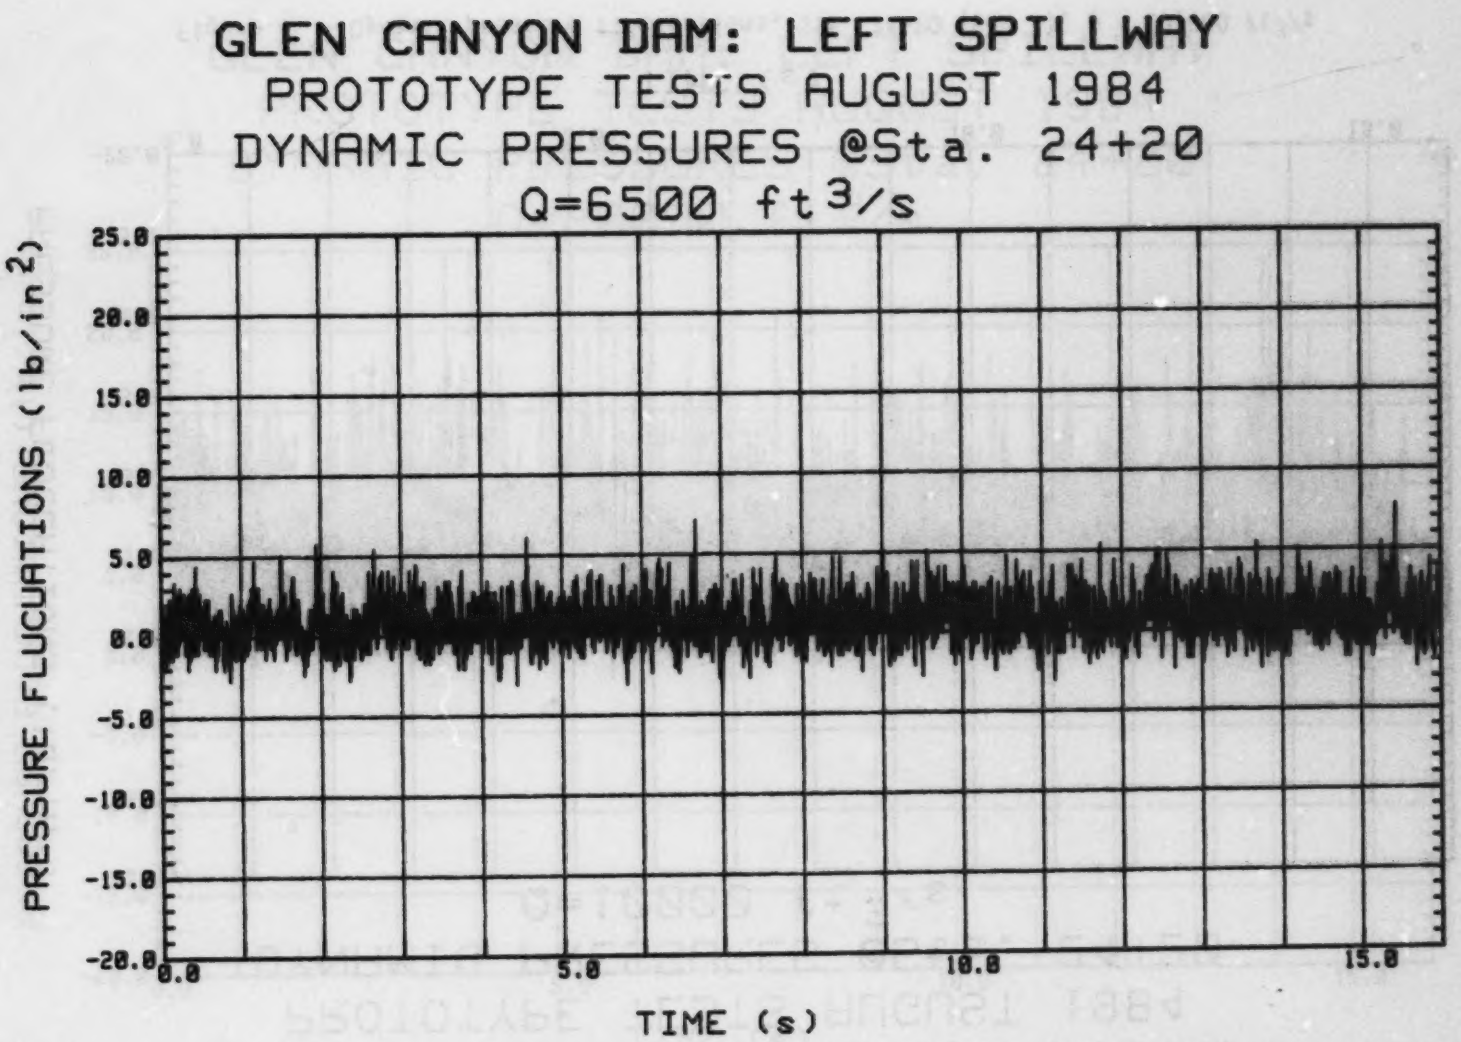
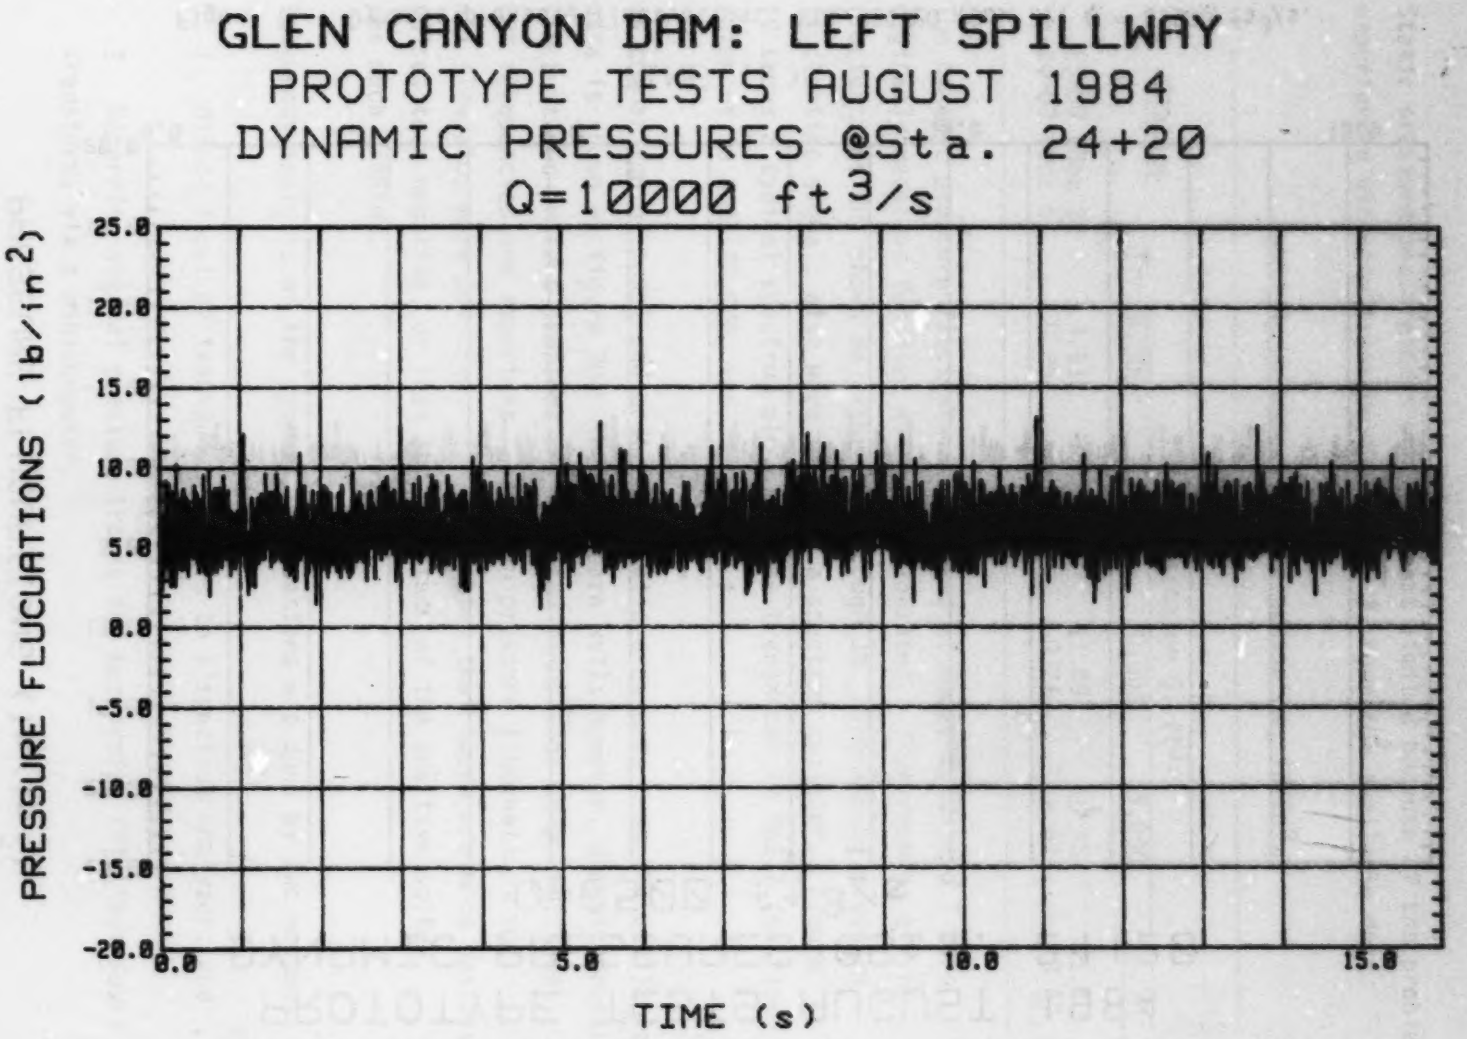
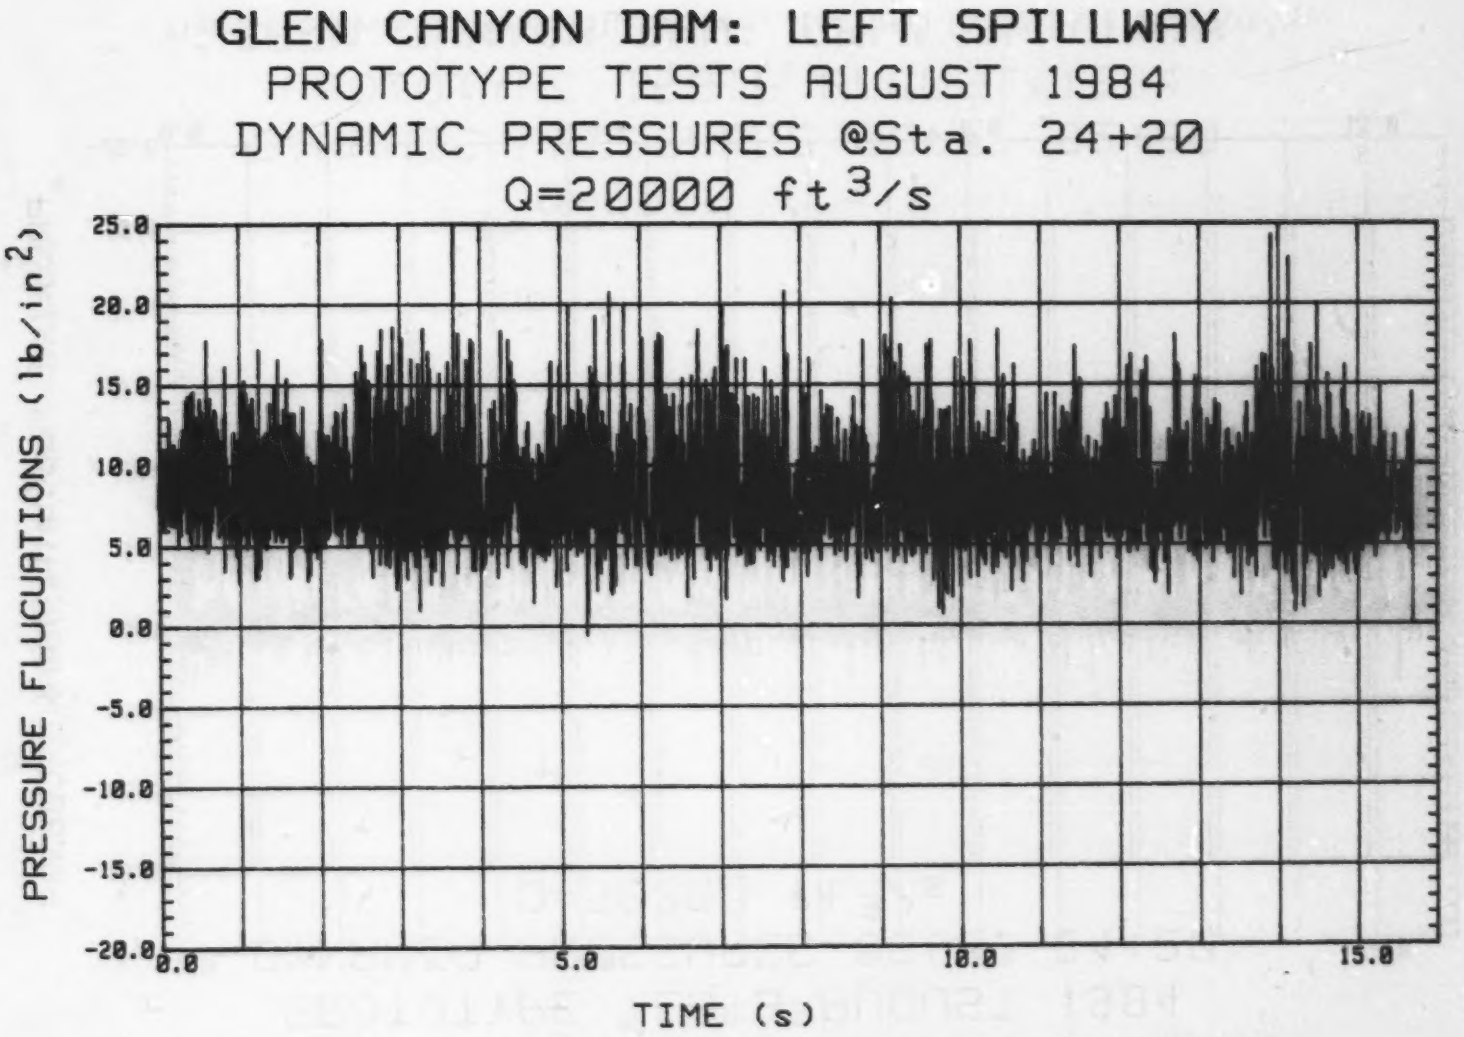
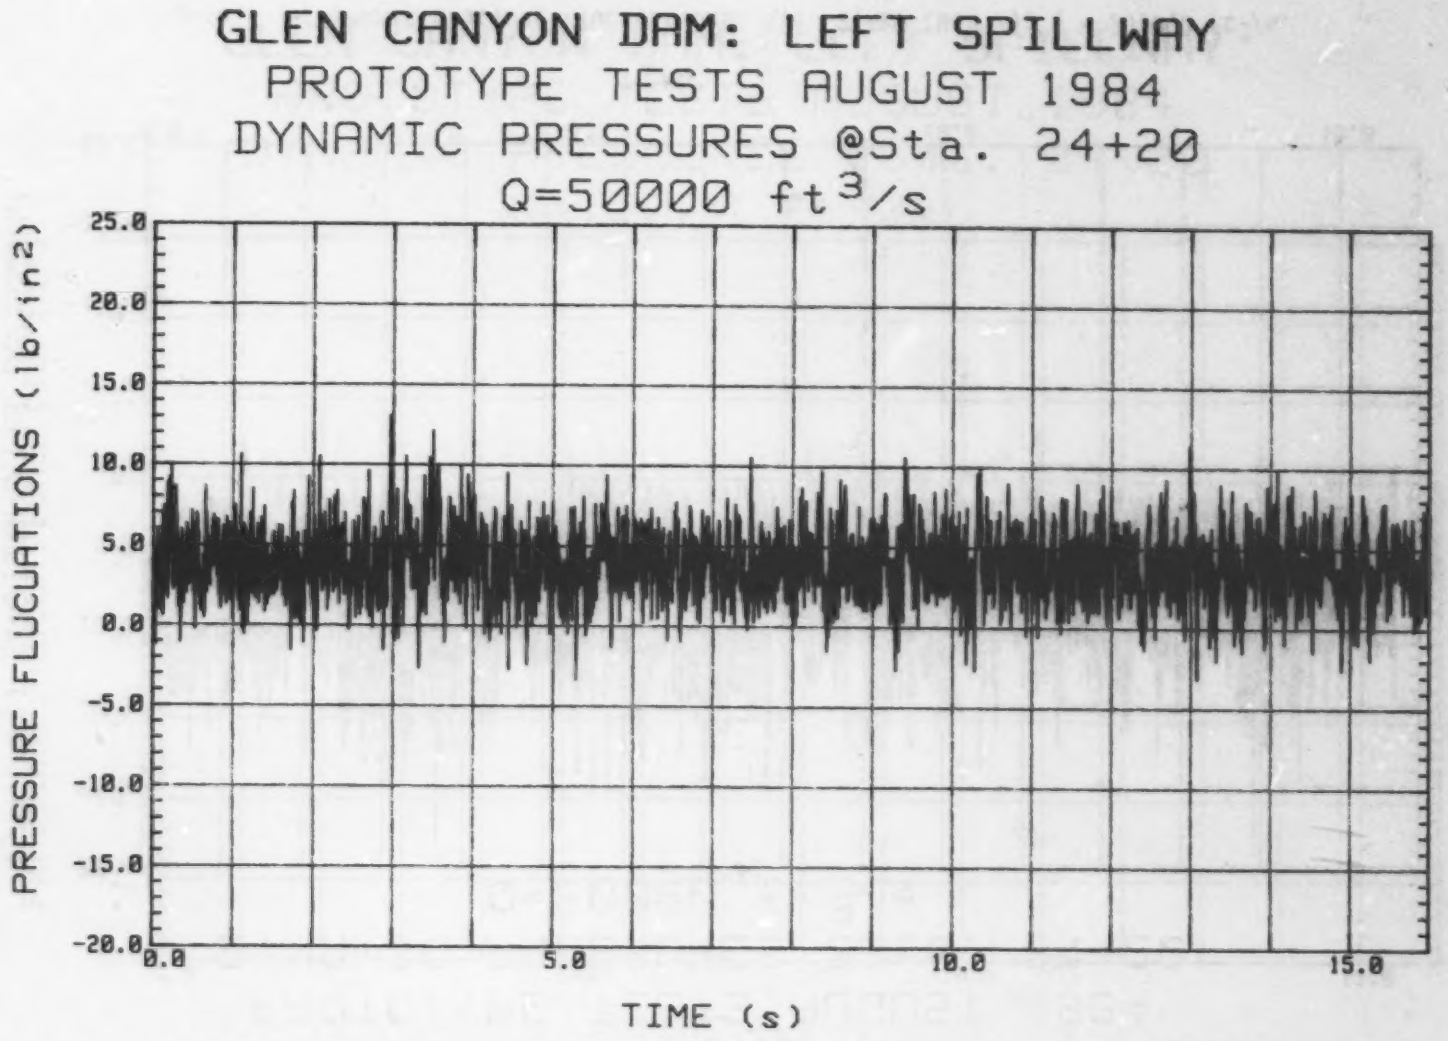
The dynamic pressure fluctuations measured at Boxes 2, 3, and 7 were digitally recorded for five different flowrates. Time records of the fluctuations are shown on figures 5 through 18. The analog pressure fluctuation signals also were fed into a spectrum analyzer. Figure 19 shows a typical spectrum plot from the transducer in Box 7 for flowrates of 10,000, 20,000, and 35,000 ft^3/s.

Figure 5. - Dynamic pressure fluctuations, Sta. 24+20 (Box 7), Q = 6,500 ft^3/s.

Figure 6. - Dynamic pressure fluctuations, Sta. 24+20 (Box 7), Q = 10,000 ft^3/s

Figure 7. - Dynamic pressure fluctuations, Sta. 24+20 (Box 7), Q = 20,000 ft^3/s.

Figure 8. - Dynamic pressure fluctuations, Sta. 24+20 (Box 7), Q = 50,000 ft^3/s.

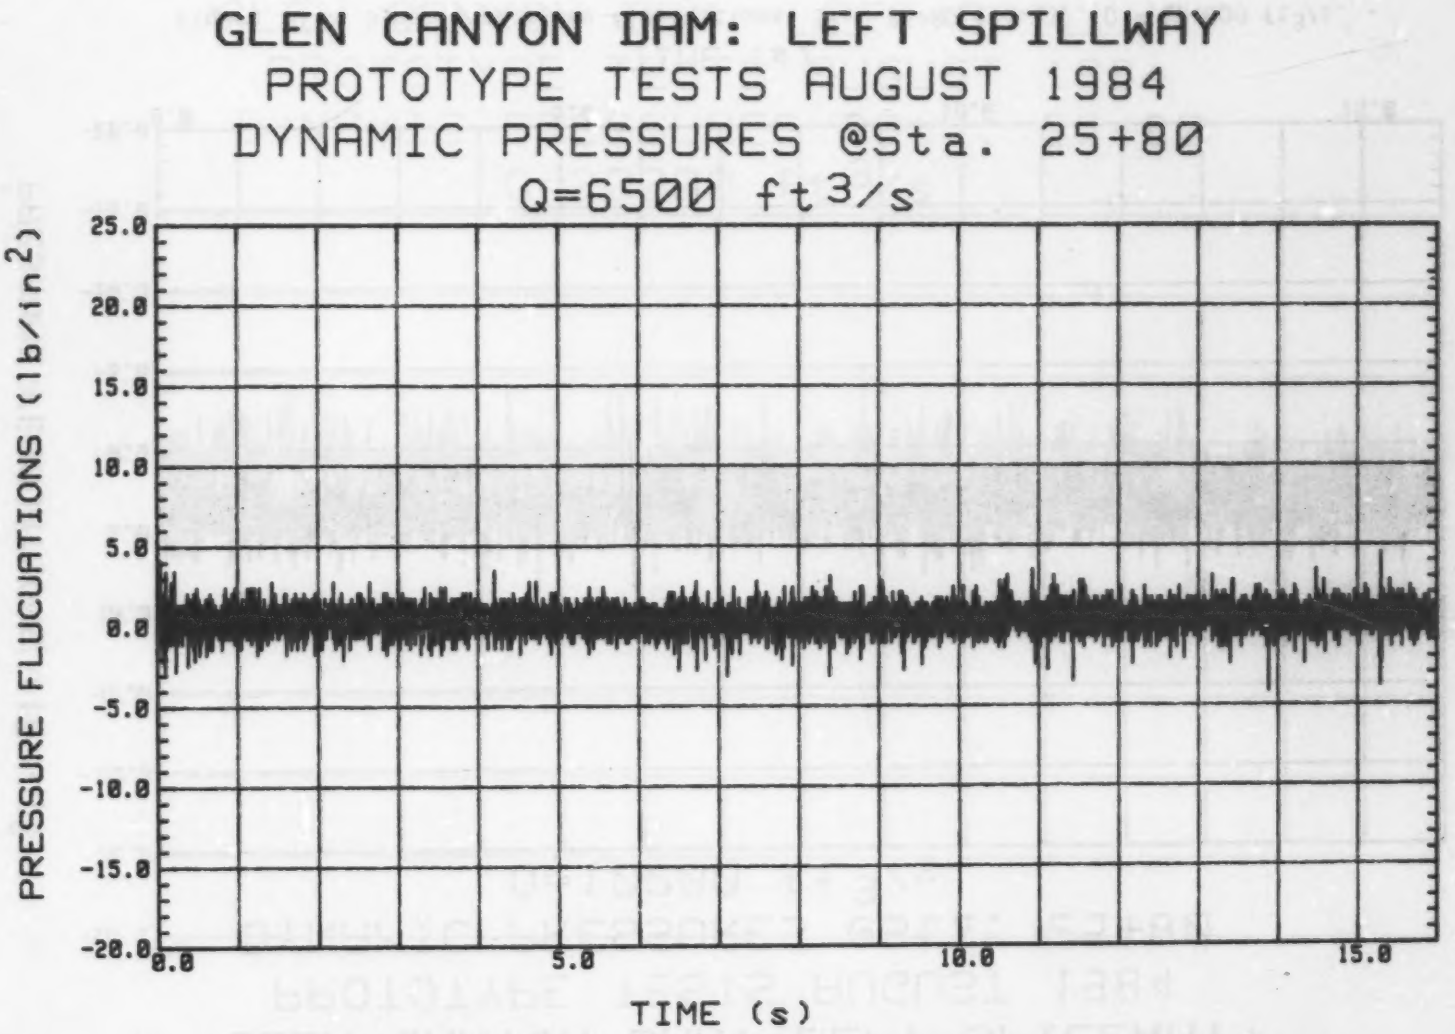
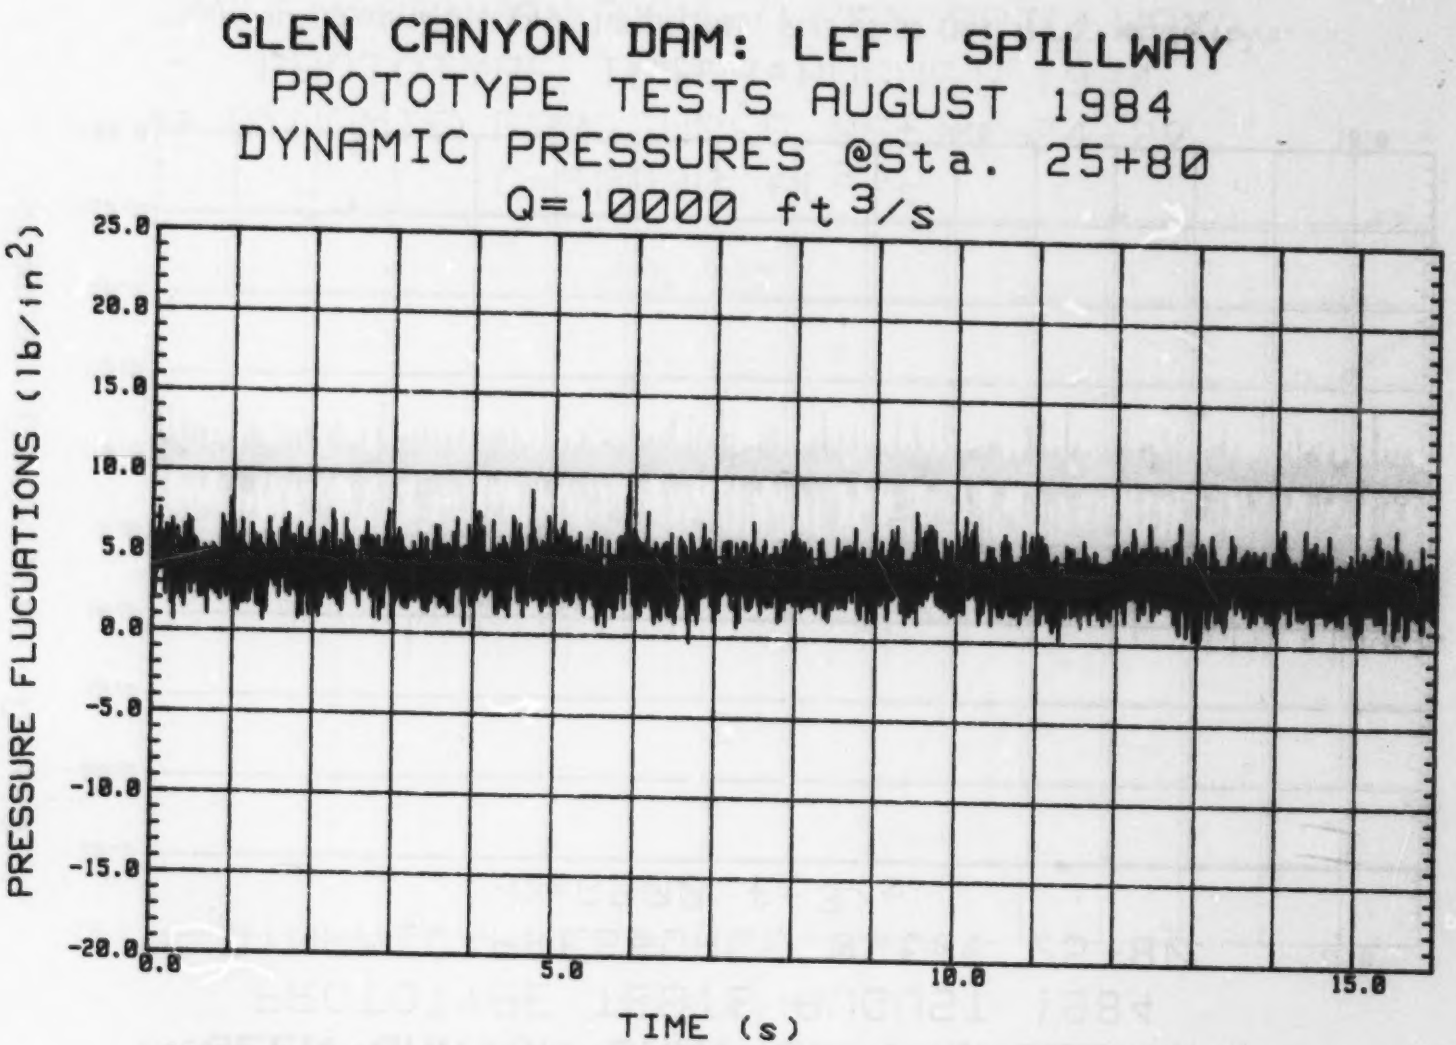
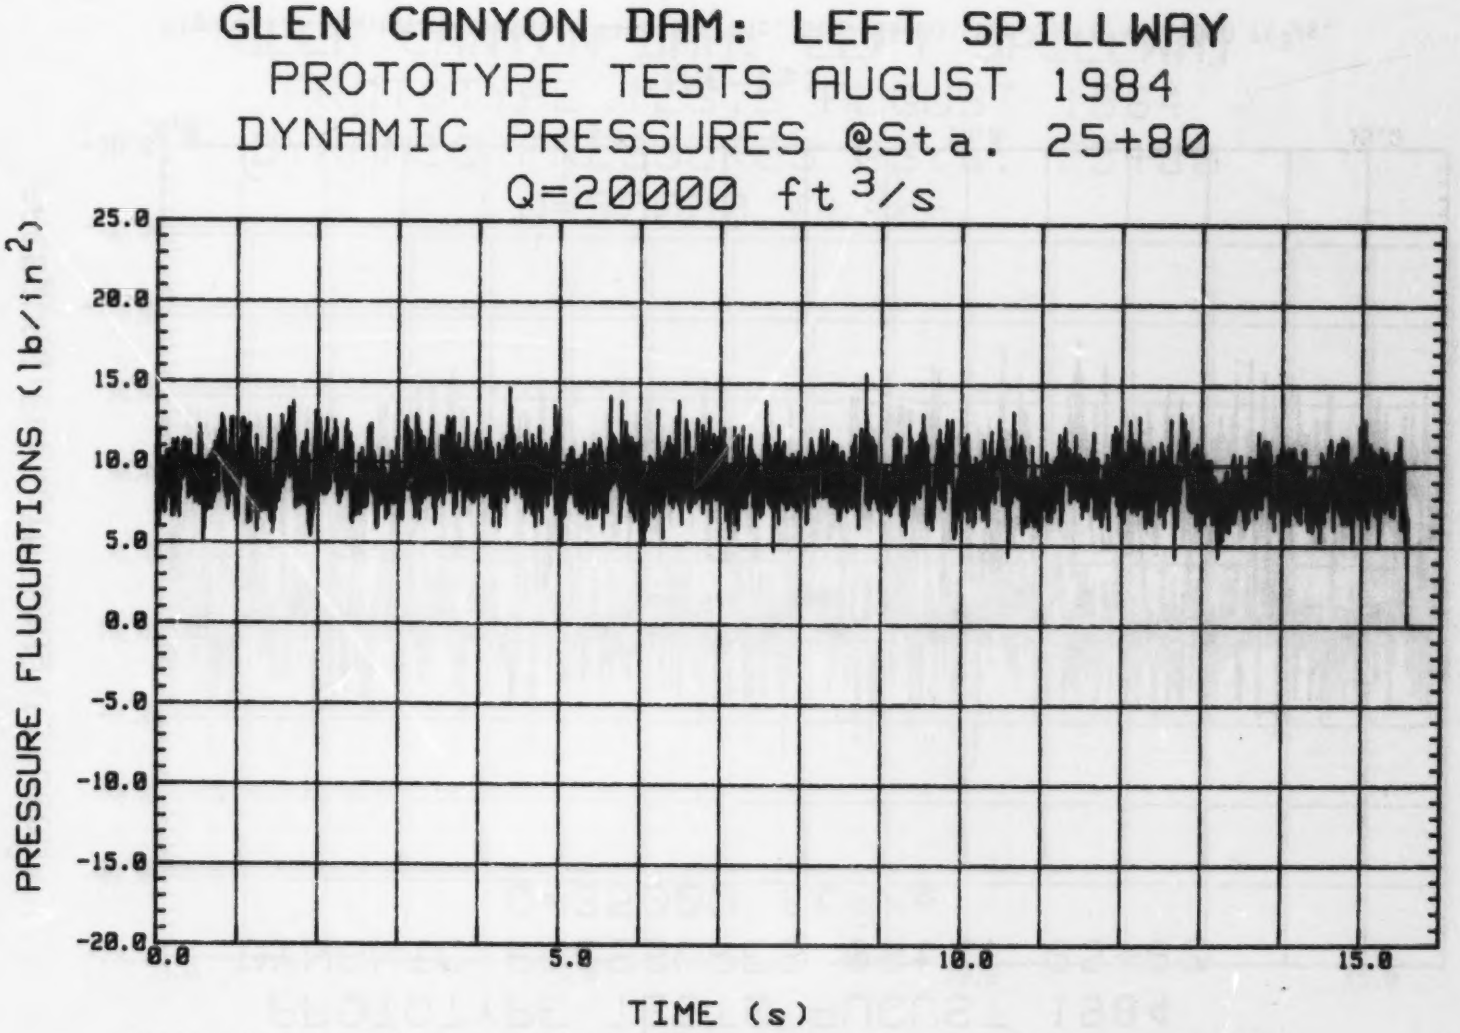
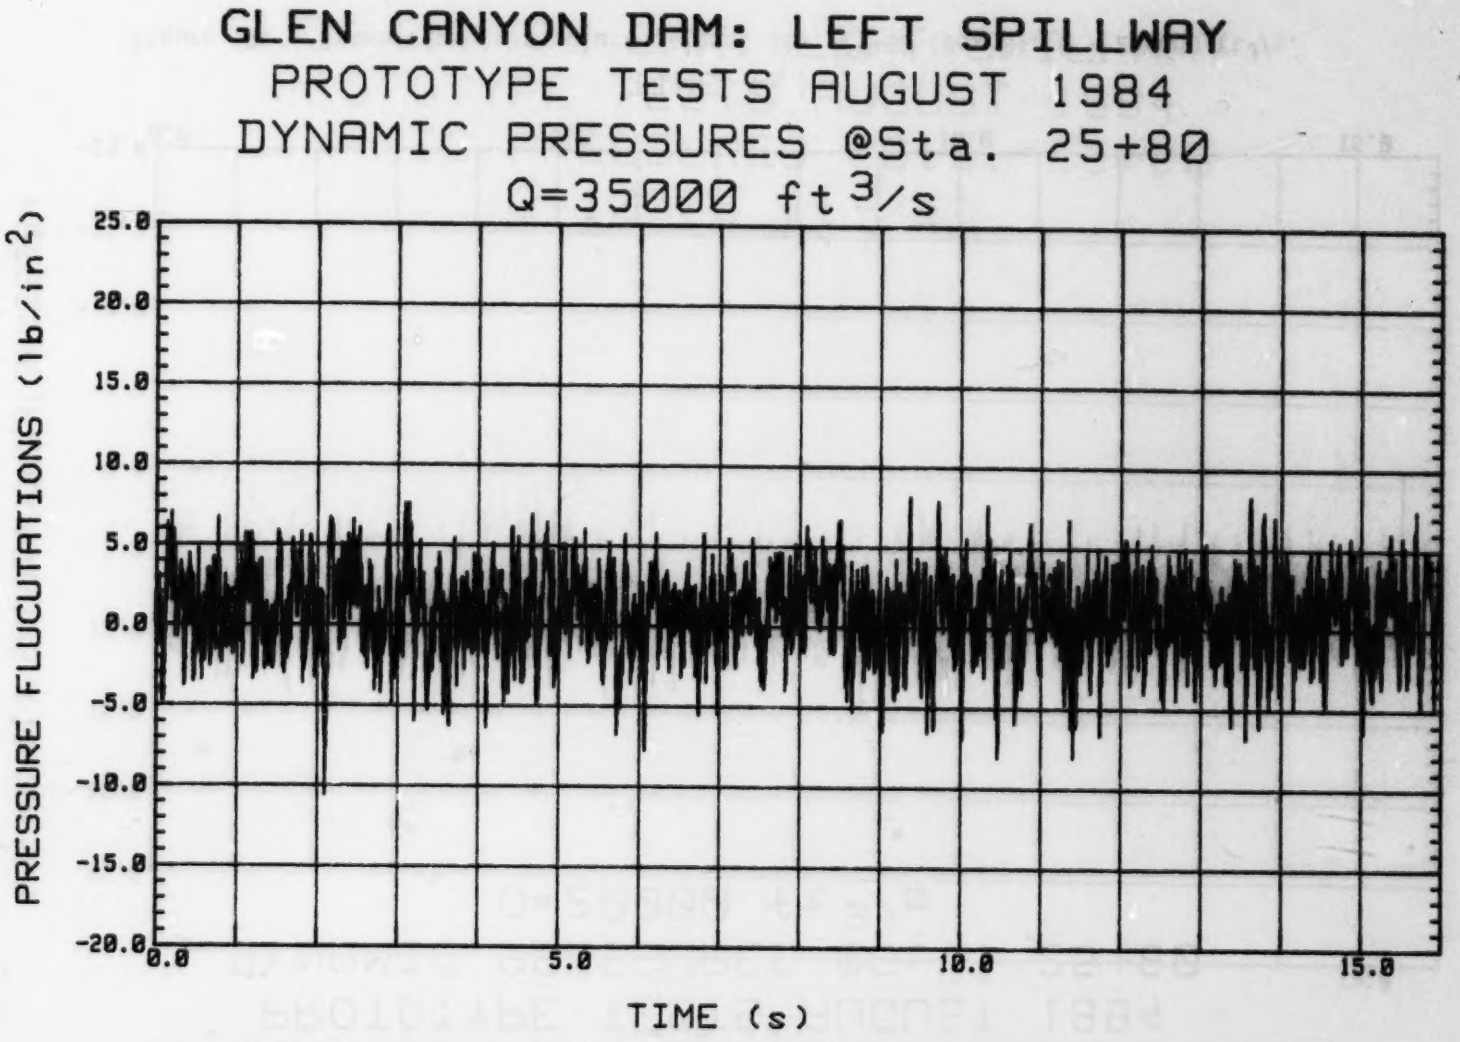
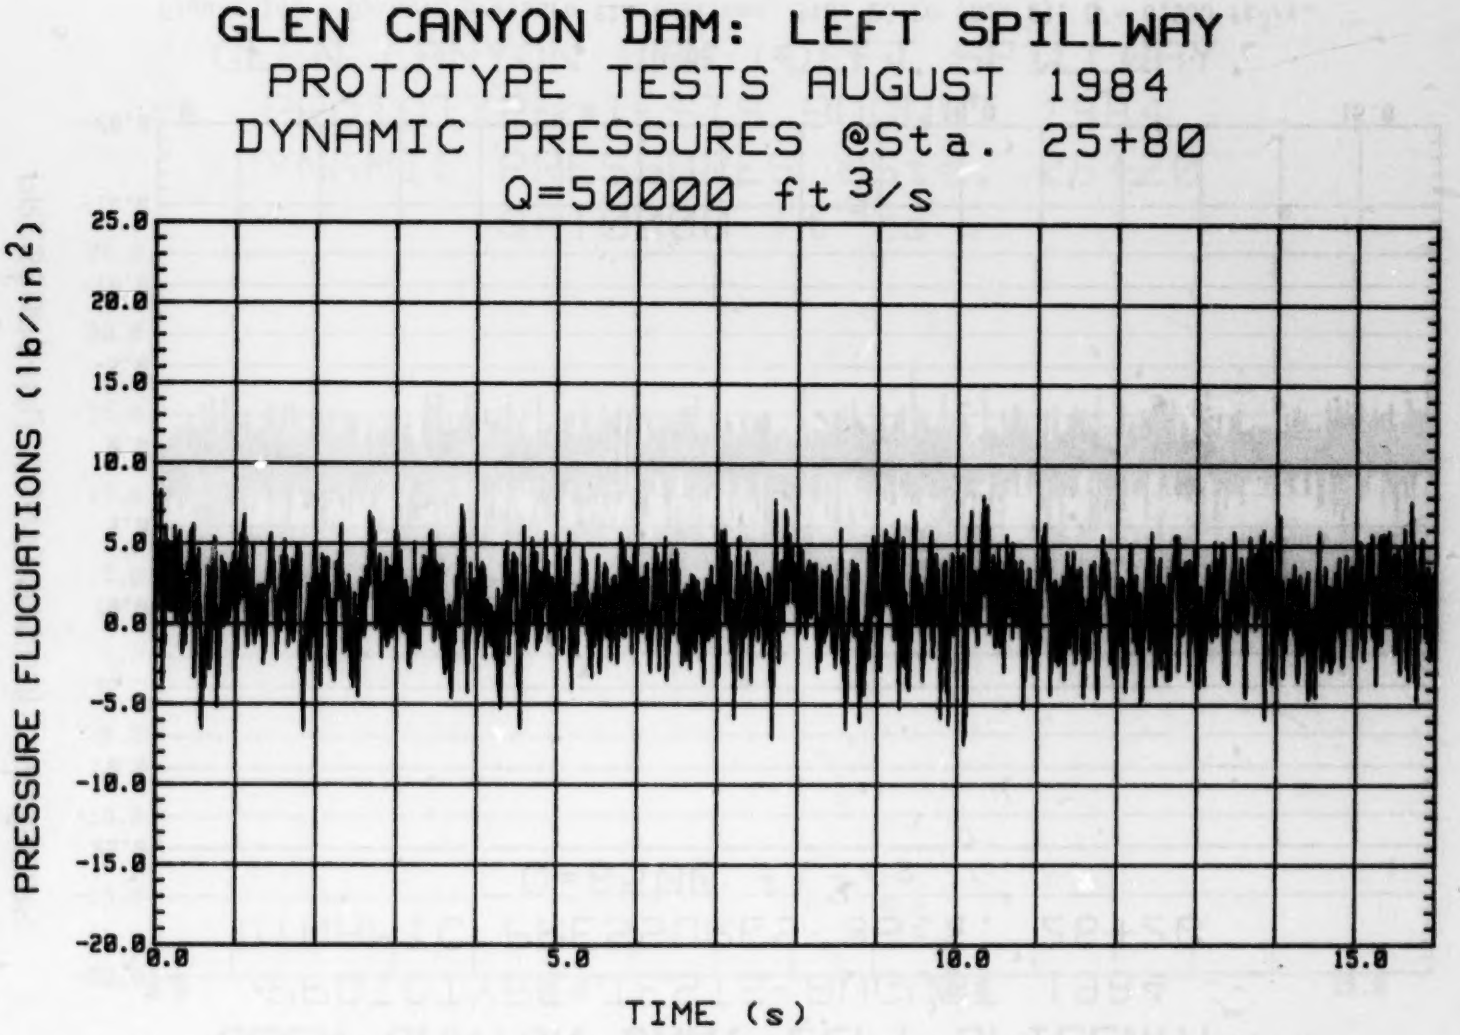
Figure 9. - Dynamic pressure fluctuations, Sta. 25+80 (Box 3), Q = 6,500 ft^3/s.

Figure 10. - Dynamic pressure fluctuations, Sta. 25+80 (Box 3), Q = 10,000 ft^3/s.

Figure 11. - Dynamic pressure fluctuations, Sta. 25+80 (Box 3), Q = 20,000 ft^3/s.

Figure 12. - Dynamic pressure fluctuations, Sta. 25+80 (Box 3), Q = 35,000 ft^3/s.

Figure 13. - Dynamic pressure fluctuations, Sta. 25+80 (Box 3), Q = 50,000 ft^3/s.
